## Blower Door Tests (EN 13829) for Quality Assurance: Getting Airtight Buildings in Retrofitting, too

Sigrid Dorschky  
Certified Tester of Airtightness  
BlowerDoor GmbH • Energie- und Umweltzentrum  
D-31832 Springe • Germany

### 1<sup>st</sup> Example (built 1920 / attic storey development 1984): $n_{50} \geq 16 \text{ h}^{-1}$ !

### 2<sup>nd</sup> Example (built 1928 / attic storey development 1997): $n_{50} = 1 \text{ h}^{-1}$ !

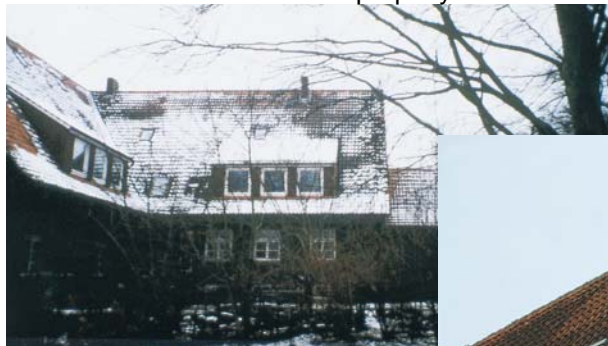
Roof Extension will not be properly sealed unless Airtightness is planned

The subject airtightness was not considered - Consequence: The rooms lying to the east didn't get warm sufficiently.

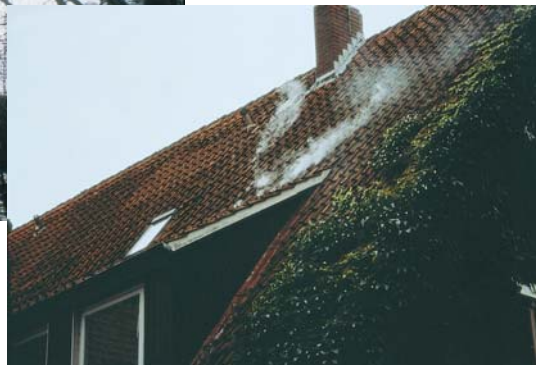
Thawed **snow** and the appearance of **fog** at **50 Pa pressurization** with **BlowerDoor** show how air is flowing at the internal walls, beam ceilings and attic areas, and that there are energy losses in spite of the 200 mm insulation thickness.

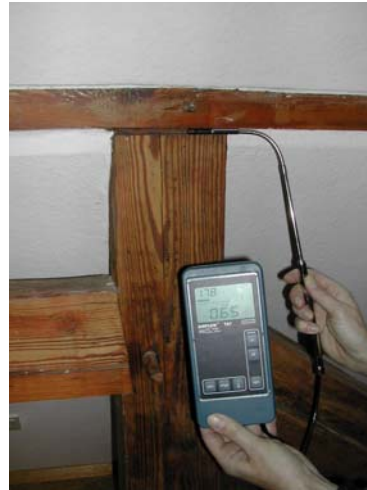
### Typical leak in attic storey developments

Air draughts at the joint between post and center purlin with 0.65 m/s - also **without** BlowerDoor! (At windy weather.)

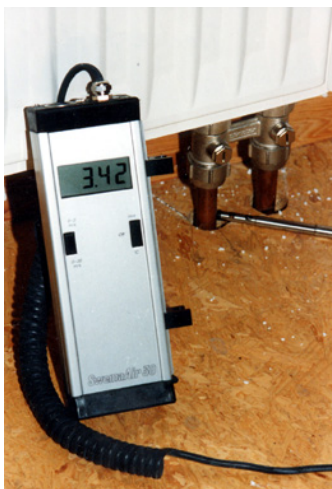
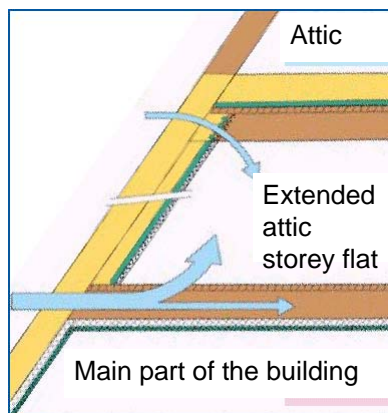
### Beam Sealings: Cold draughts flow through the ceiling!

With 50 Pascal depressurization during the BlowerDoor test air is flowing at the ceiling opening with 3.4 m/s: There is an **incomplete** airtight layer at the ceiling joints.

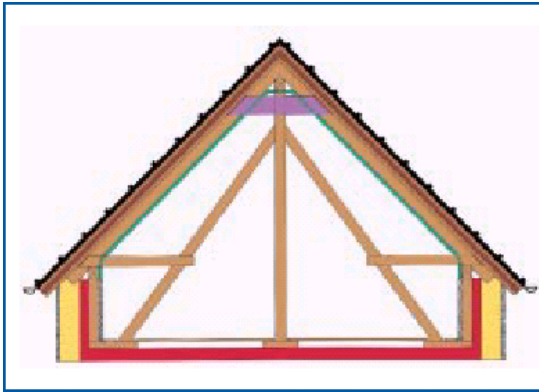
The airtight layer was planned in detail and checked with the blower door during construction.

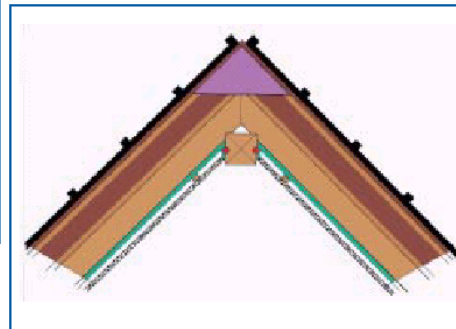
Original design offered by the static engineer to reinforce the ridge purlin for the rafters: **penetrating shackles** which cannot be easily, economically and permanently sealed...

... and the alternative that was built: **triangles** at the tips of the locking rafters **outside the airtight layer**, which is attached along the ridge purlin

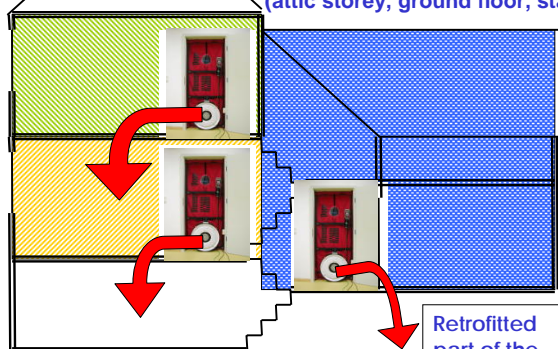
### Guard Zone Measurement \*) with 3 BlowerDoor Systems to determine the Air Permeability -

Upper floor flat:  $n_{50} = 3 \text{ h}^{-1}$

Ground floor flat:  $n_{50} = 3 \text{ h}^{-1}$

Retrofitted part of the building:  $n_{50} = 1 \text{ h}^{-1}$
